LEVEL ONE EARTHWORKS COMPLIANCE REPORT

DL18/267 – Everleigh Precinct 1.2A Subdivision Development

Teviot Road, Greenbank

LOTS 1297, 1298, 1131 AND 1132 EVERLEIGH PRECINCT 1.2A TEVIOT ROAD, GREENBANK

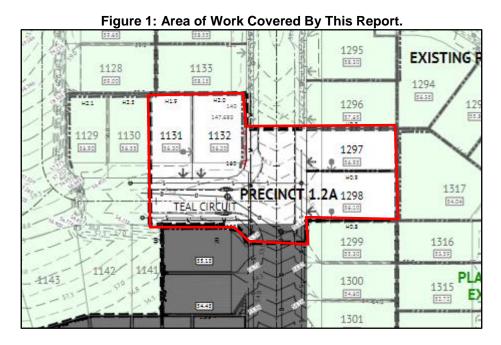
Fill was constructed on the following lots that are shown as Figure 1 below: -

- Lots 1297 1298
- o Lots 1131 1132

The actual thickness of fill on an individual Lot can be obtained from the Developer as a Lot Disclosure Plan.

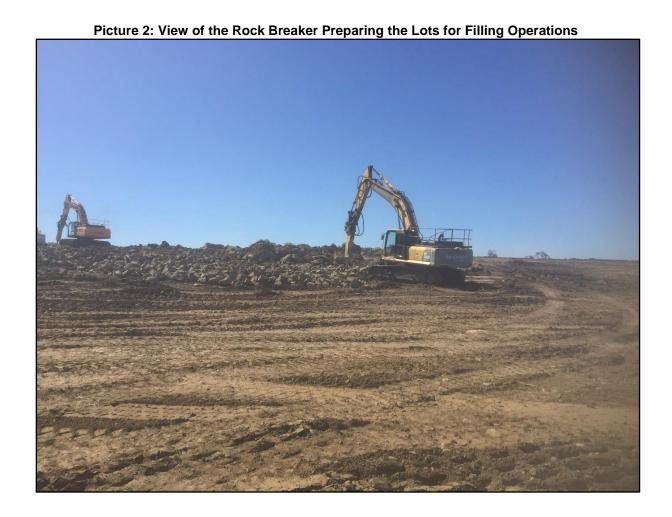
The area covered by this report was excavated to a depth of approximately 0.5m below the design earthworks levels. Materials exposed at this level and formed the fill foundation can be broadly summarised as:

• Natural – Sandstone Rock (XW-DW) – Extremely weathered to distinctly weathered, at least medium strength, orange – yellow mottled brown – grey.

Following the stripped surface assessment of the fill areas, the foundation was approved for filling using the following process:

• Walk over assessments confirming that rock was exposed at the fill foundation level.

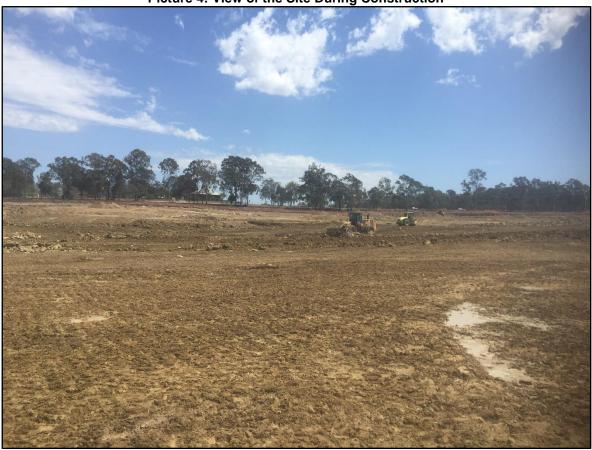
Picture 4: View of the Site During Construction

The fill materials were moisture conditioned at the fill source and during placement to moisture contents suitable for compaction. Deleterious materials such as organics, sticks, roots and over size particles were sorted and removed during placement or were rejected for use. Occasional oversize particles including cobbles and boulders may be present in the deeper fill profile, however are not considered to affect the fill as a mass.

Placement of the fill materials was carried out in layers appropriate for the above plant and compacted using the above plant carrying out multiple passes.

Our representative observed the filling process as described above and was assessed to be consistent for the entire thickness of fill.

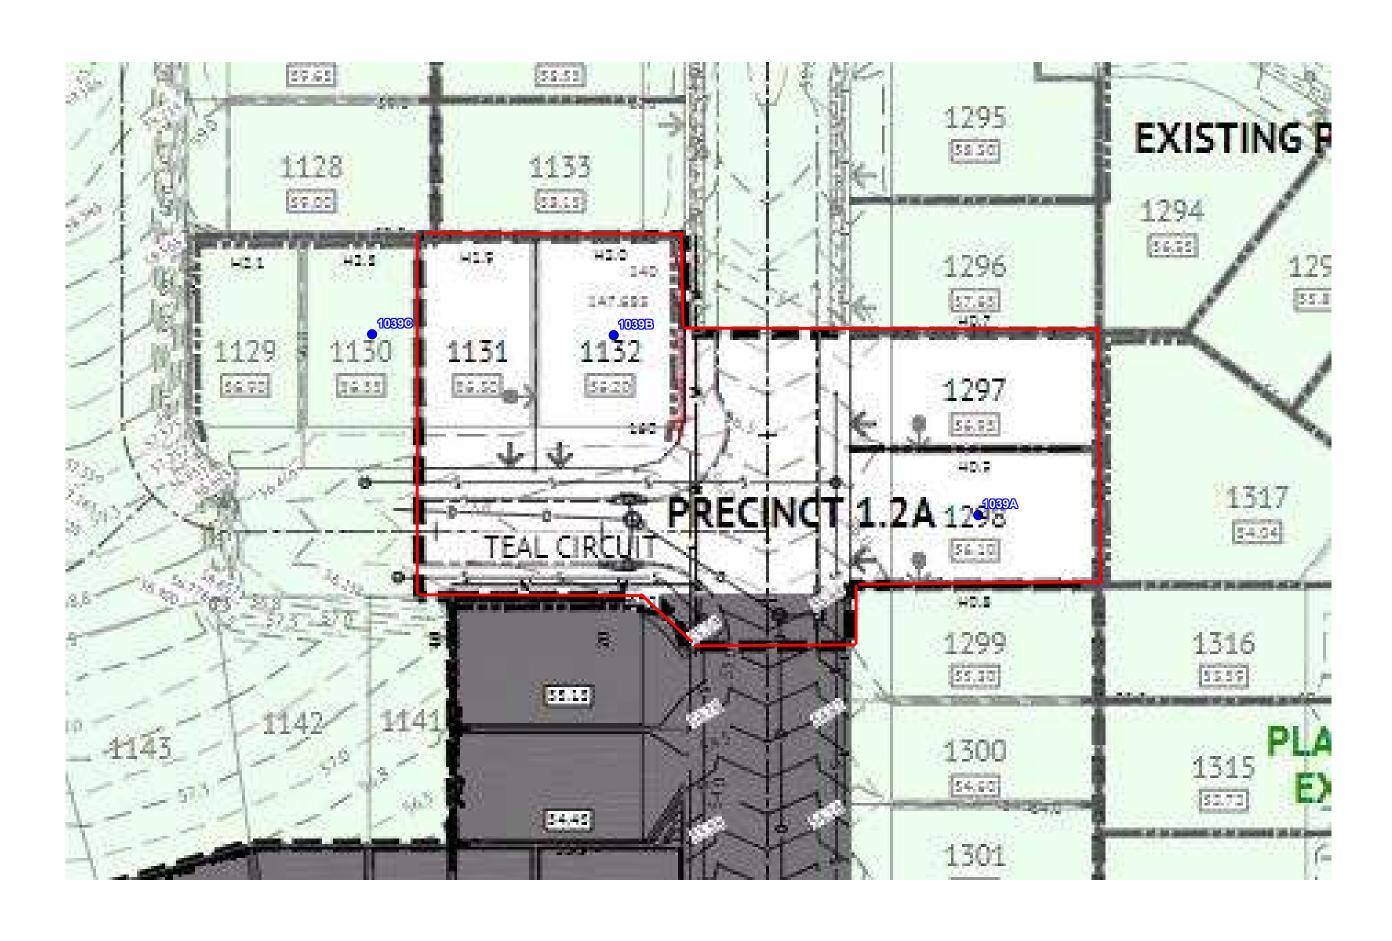
lap Description:	EARTHWORK	S FIELD DE	NSITY TESTING -	Level 1	Inspection
Client :	SHADFORTH	CIVIL PTY	LTD		
Project :	Everleigh Pre	ecinct 1.2A	Subdivision De	velopm	ent
Project No:	DL18/269	Drawing No :	DL18/269-01	Scale :	Not to Scale

The Location of the field density tests are shown on the Site Plan contained in Appendix A. These test locations and levels were not obtained by survey and therefore should only be considered as approximate.
